Oil pan leaks in the Ford F-150 2.7 L EcoBoost engines from 2015 to 2017

ElringKlinger AG | Aftermarket Division

SI 07/2024

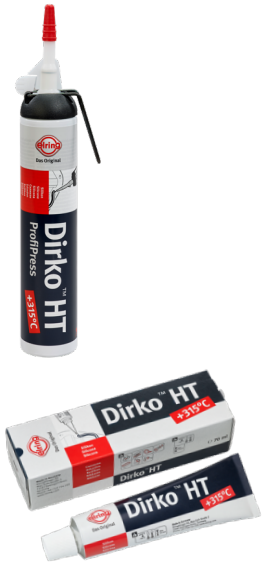
1. Remove all sealing residue with a plastic scraper and then clean the surfaces thoroughly with a solvent.
2. Sealing surfaces must be clean, dry and free of oil and grease before applying the sealant to ensure reliable sealing and adhesion.
3. Apply a .180“ (4.5 mm) bead of Dirko sealant to the surface of the oil pan and a .350“ (9.0 mm) bead of Dirko sealant at the front cover and rear cover joints on the block stiffener.
4. Install the oil pan within 5-10 minutes after application and tighten the bolts from the center outward in a circular pattern. First step of tightening with 31 in-lbs (4 Nm) and second step of tightening with 89 in-lbs (10 Nm).

The oil pan must be removed and prepared for the application of the sealant. Please proceed as described below.
